Container Inspection...

7-Point Container Inspection Process:

Supply Chain Security in a New Business Environment

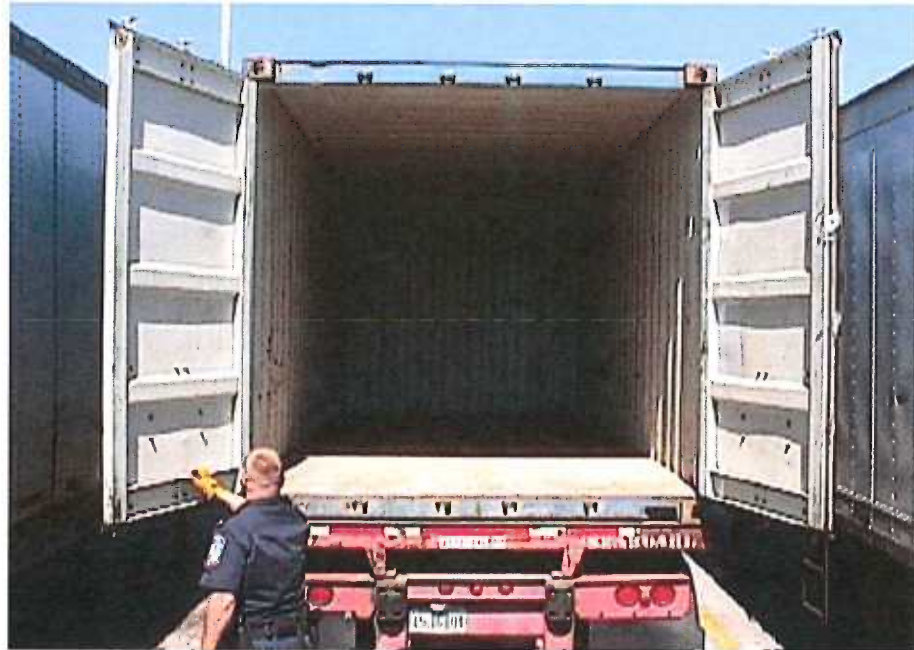
1. Outside/ Undercarriage (before entering facility)
2. Inside/ Outside doors
3. Right side
4. Left Side
5. Front Wall
6. Ceiling/Roof
7. Floor (Inside)

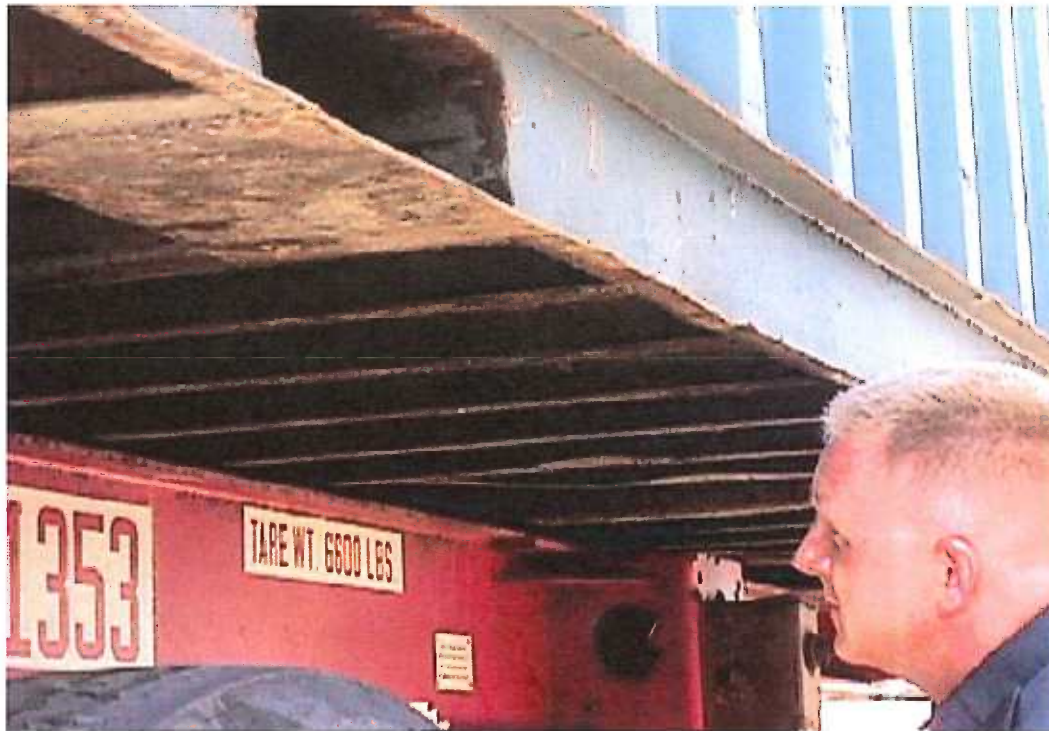
1. Undercarriage:

- Inspect prior to entering facility
- Support beams should be visible

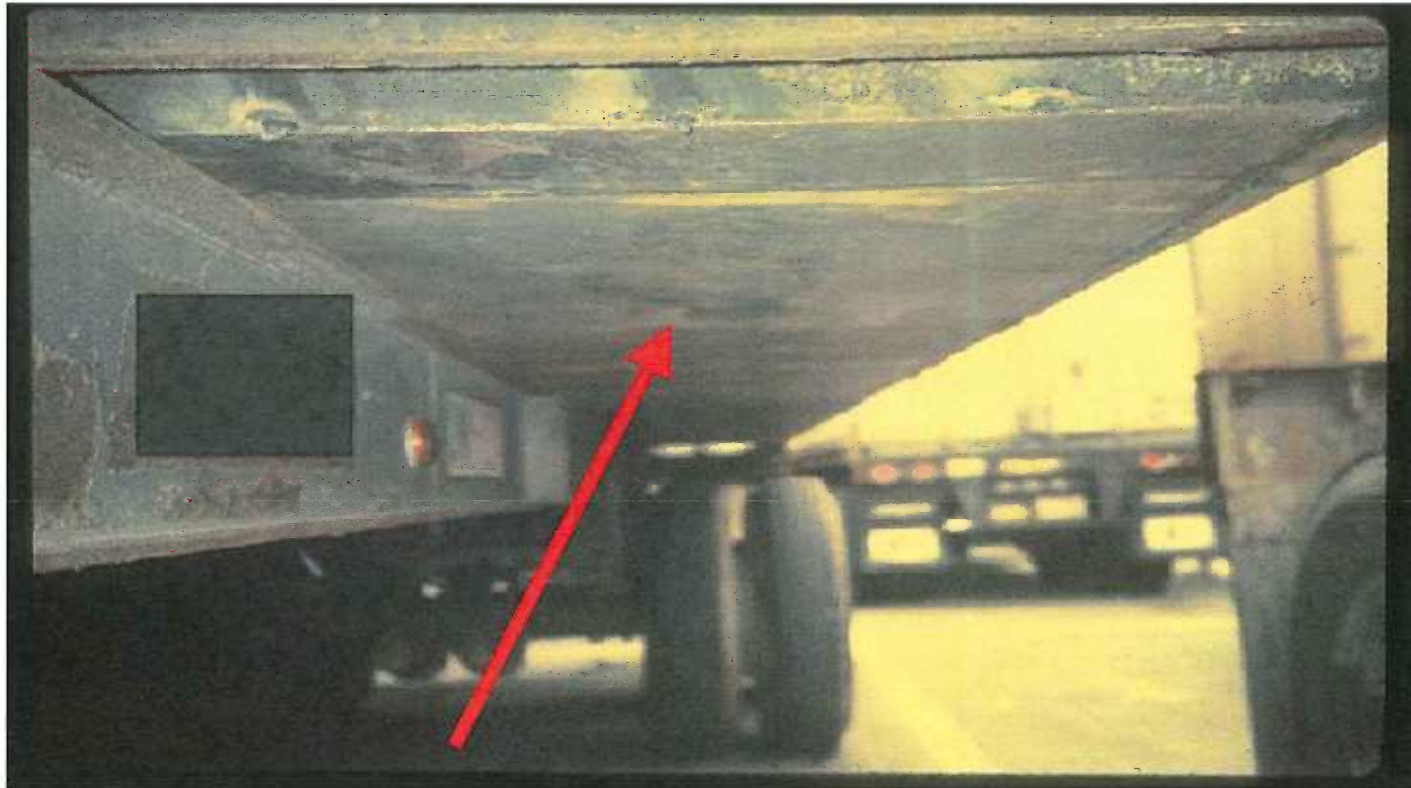
Solid plate/ Support beams not visible.

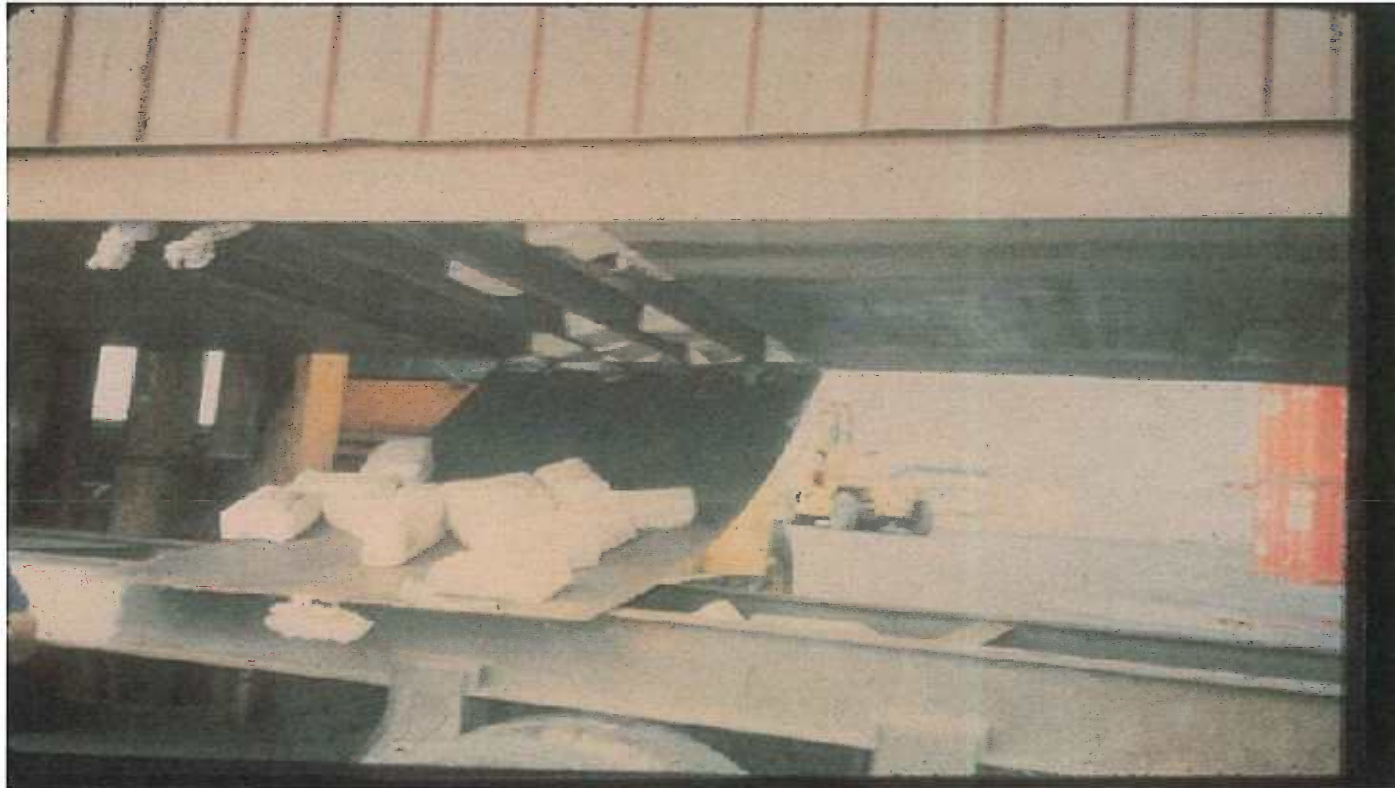
432 lbs. of cocaine!

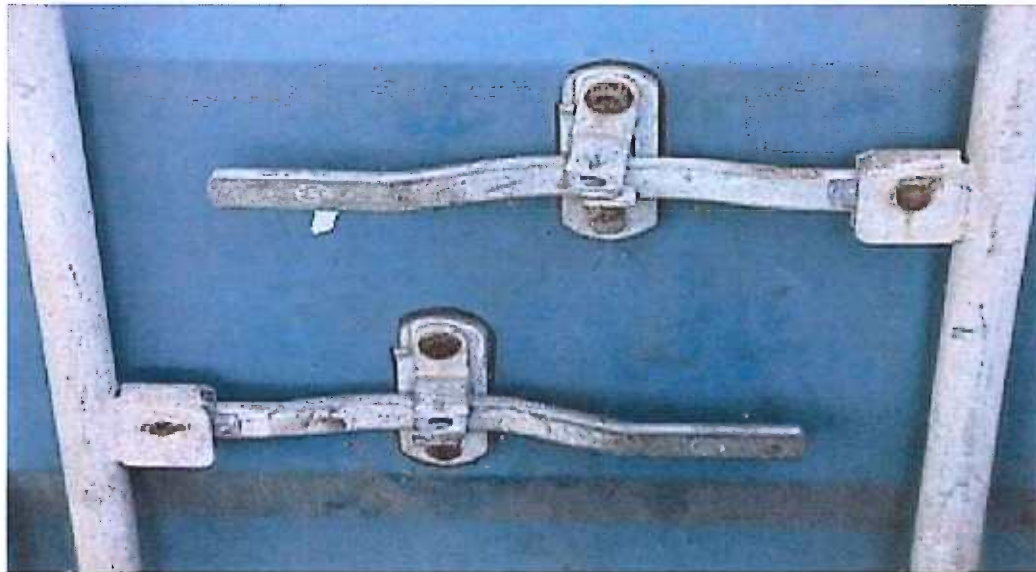
- **Secure and reliable locking mechanisms**
- **Look for different color bonding material**
- **Loose Bolts**
- **Plates and repairs**

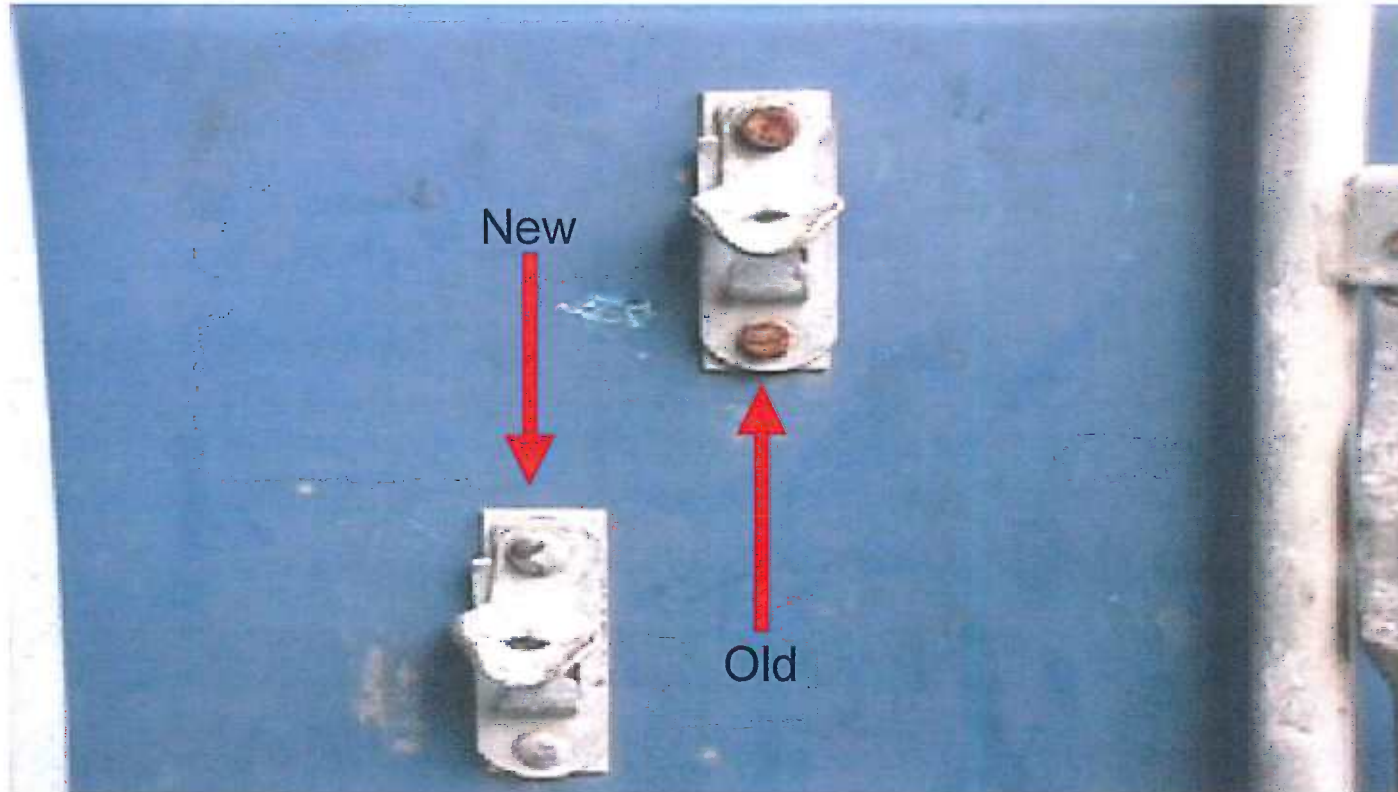
Rivet type & color/ New & old rivets together.

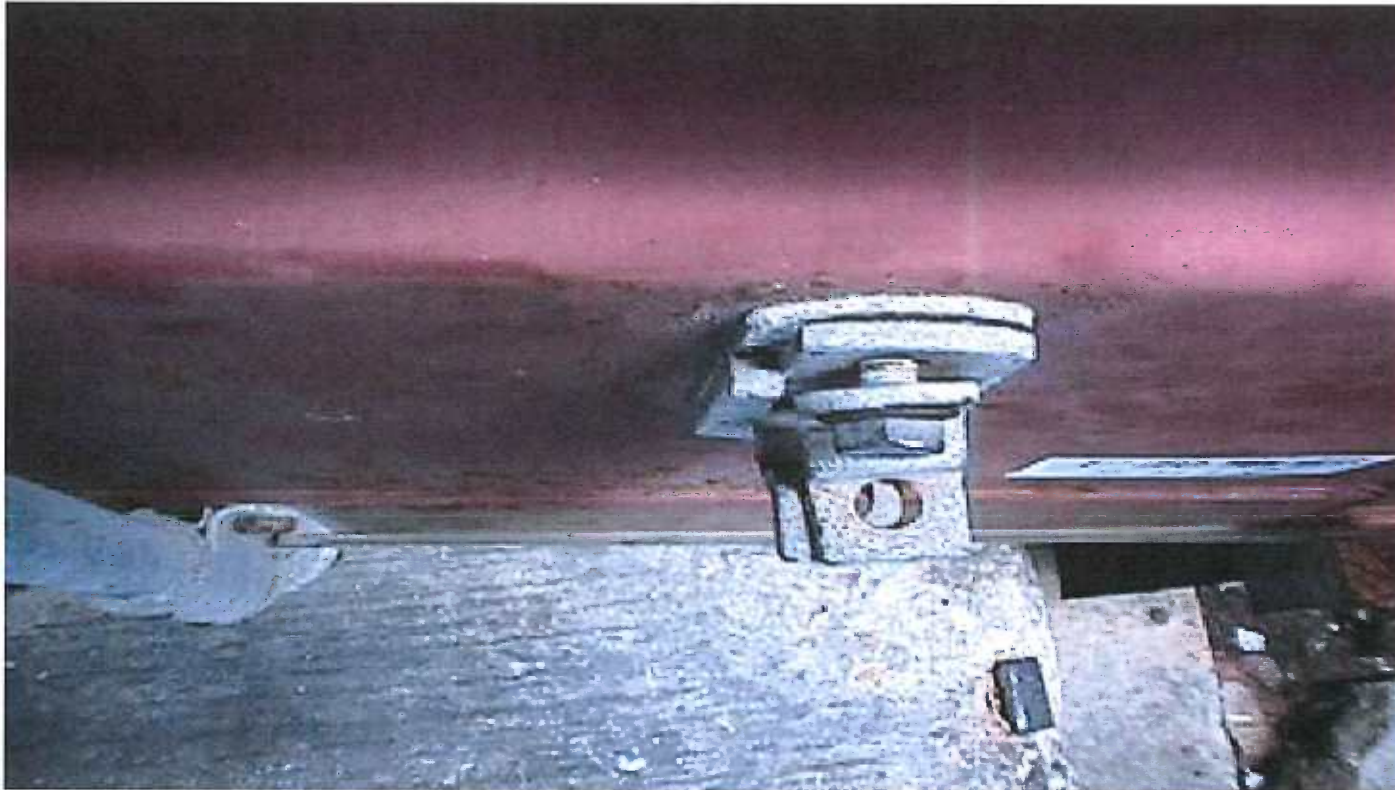
Detachable or loose bolts can allow access inside container.

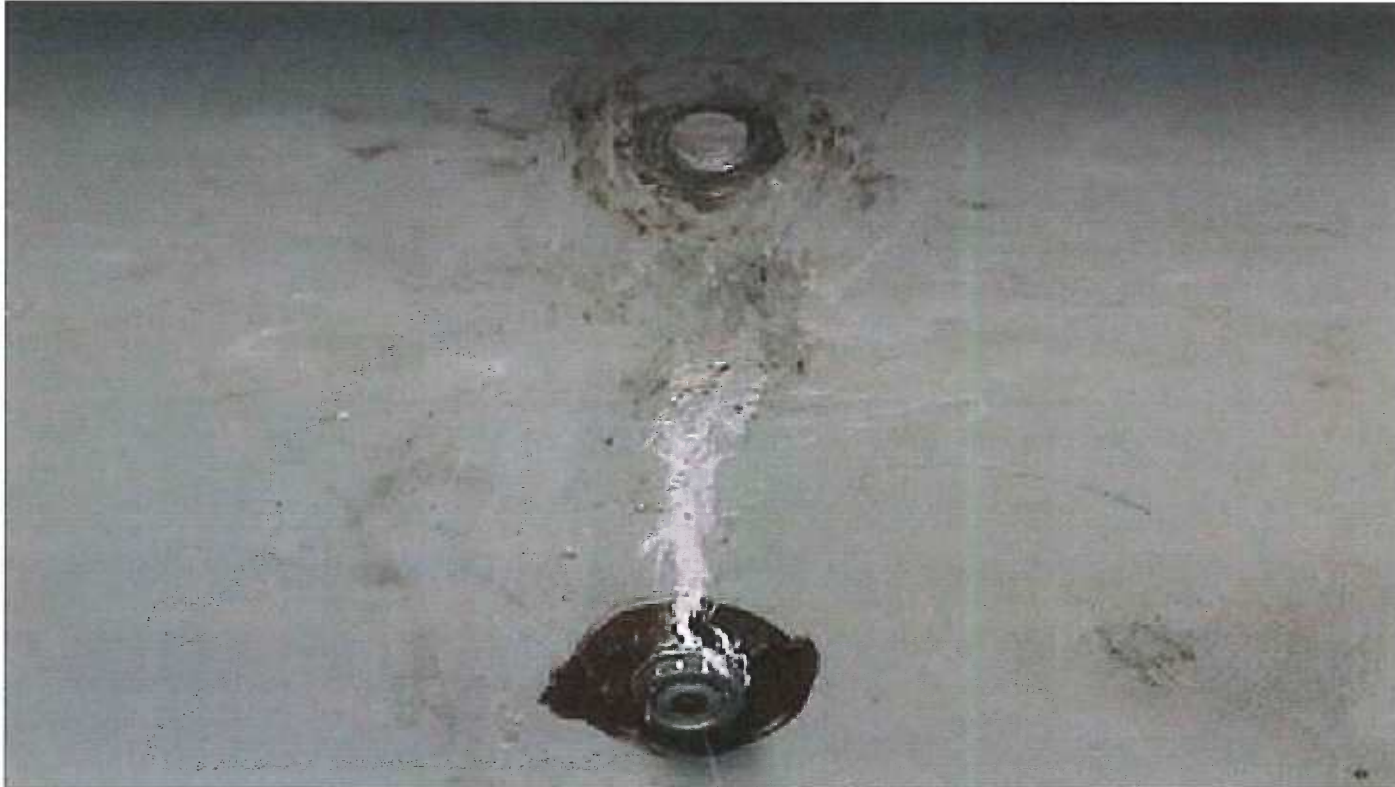
Chemicals are used to make bolts look old and rusty.

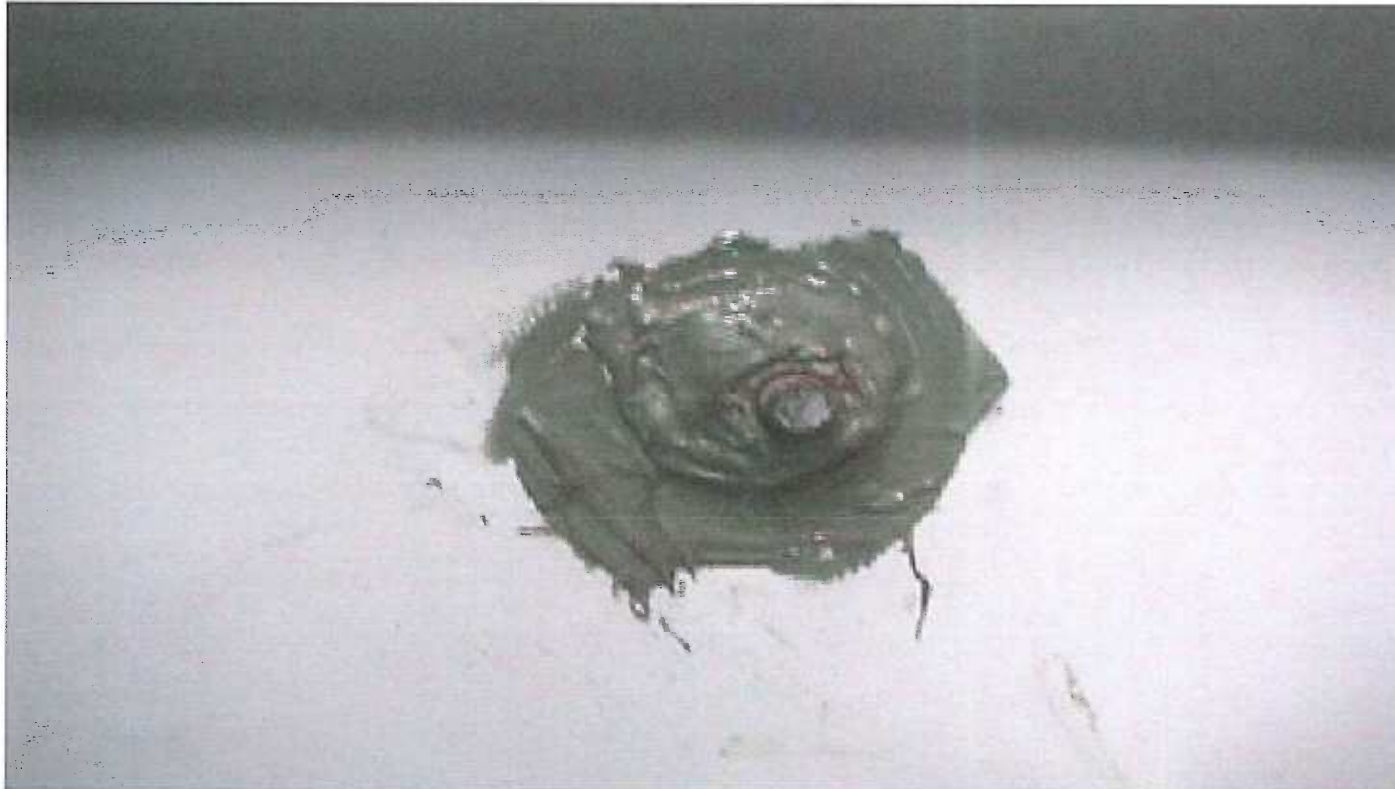
Non-factory putty keeps bolts in place.

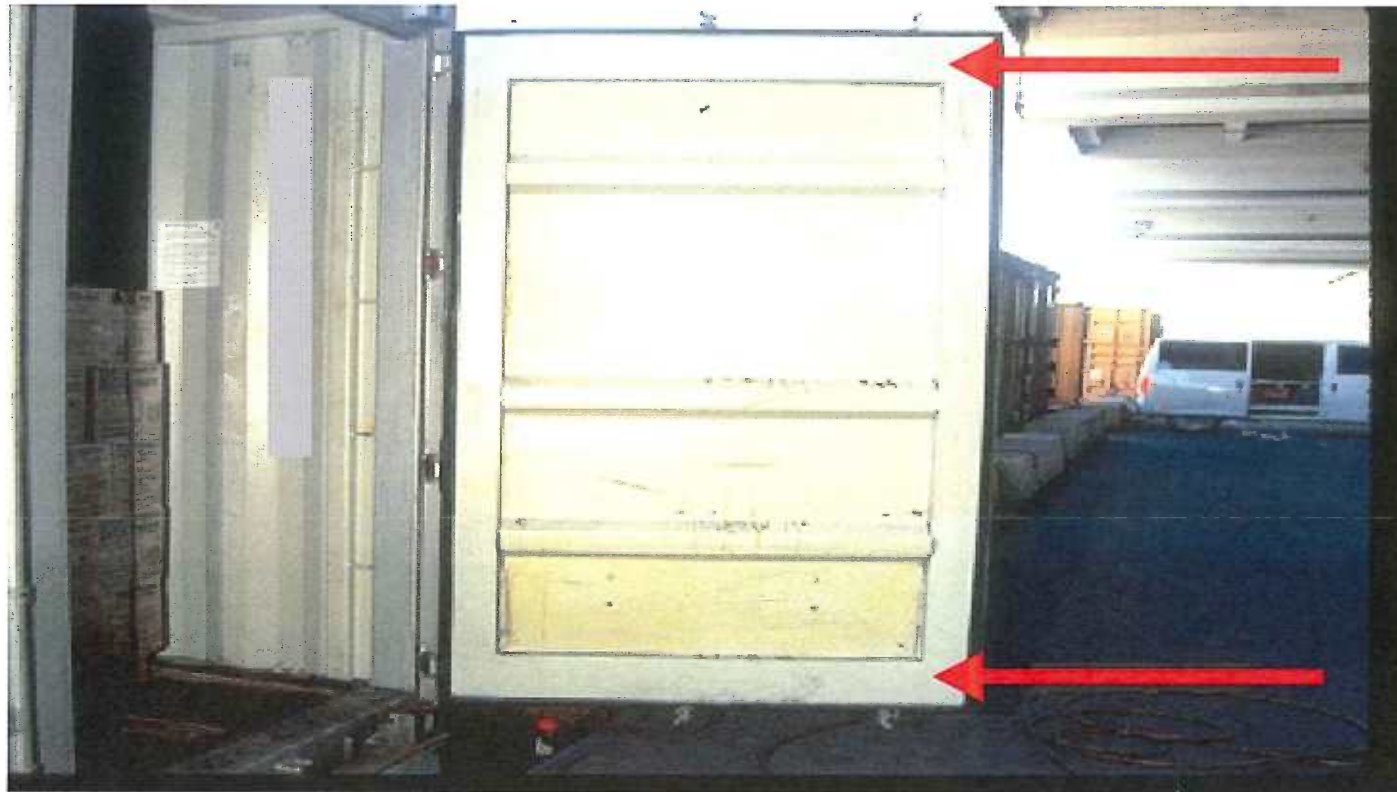
Solid plates should not cover standard container cavities.

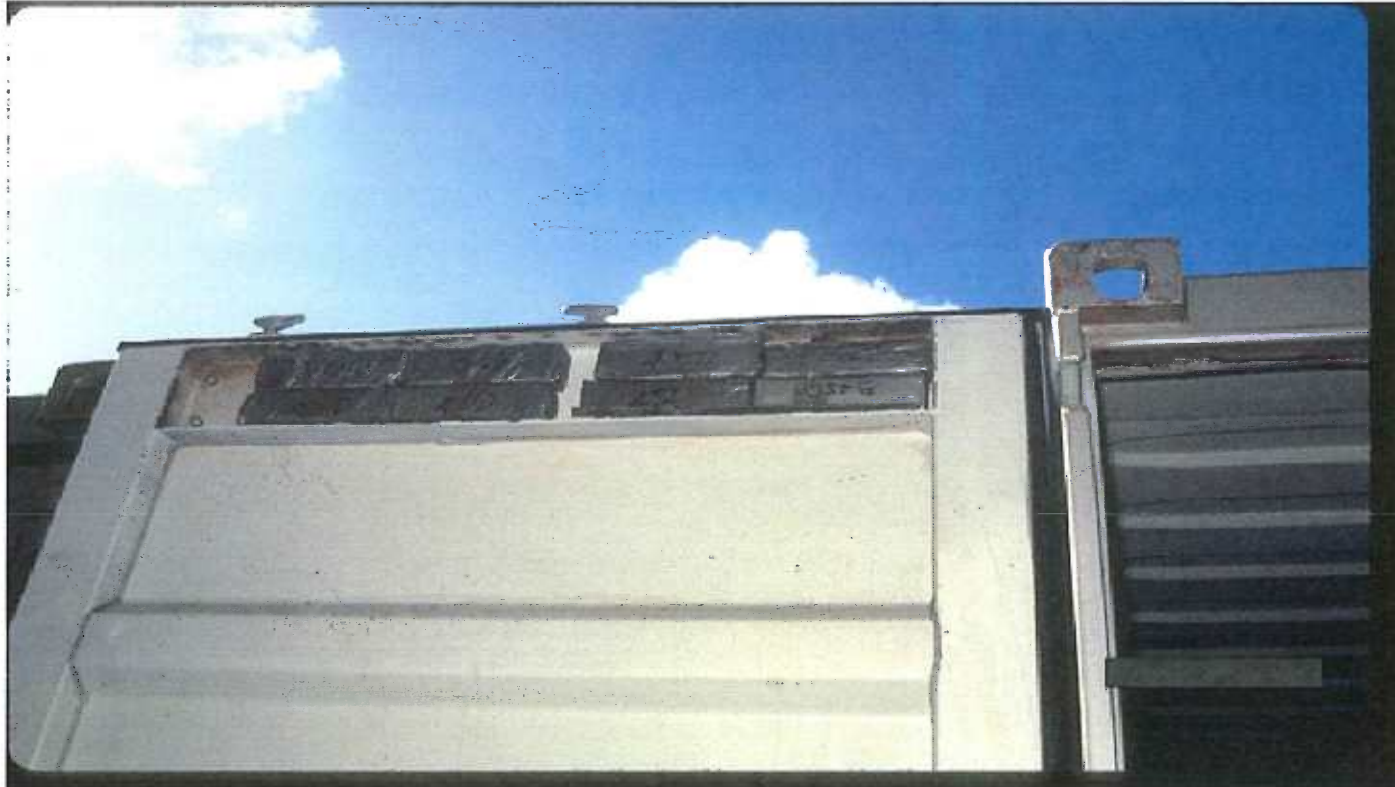
Container cavities. Five container shipment/ 837 lbs. of cocaine.

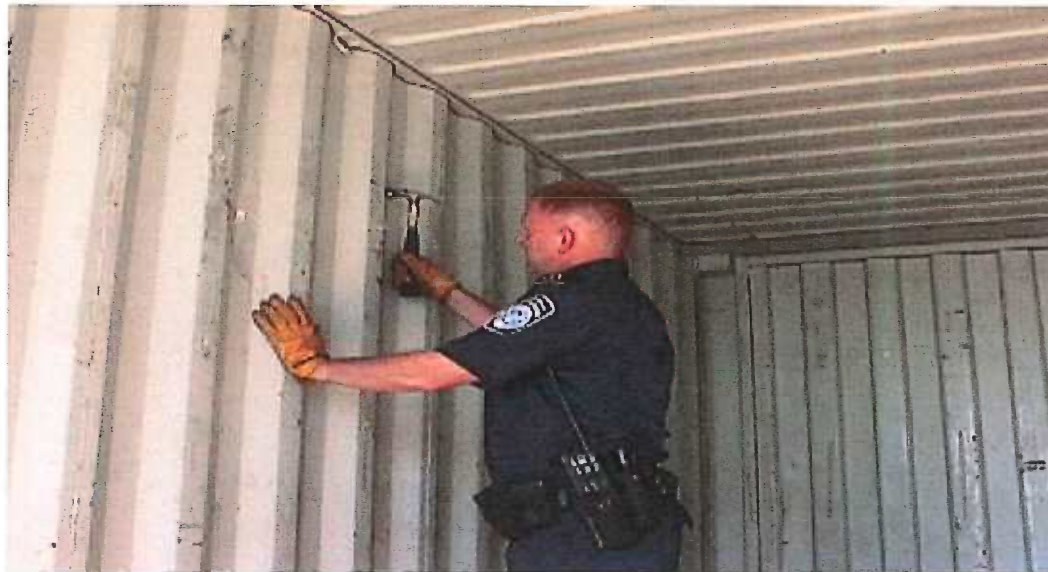
- Unusual repairs to structural beams.
- Repairs to the walls on the inside of the container must be visible on the outside.
- Use tool to tap side walls. Listen & feel for hollow sound!

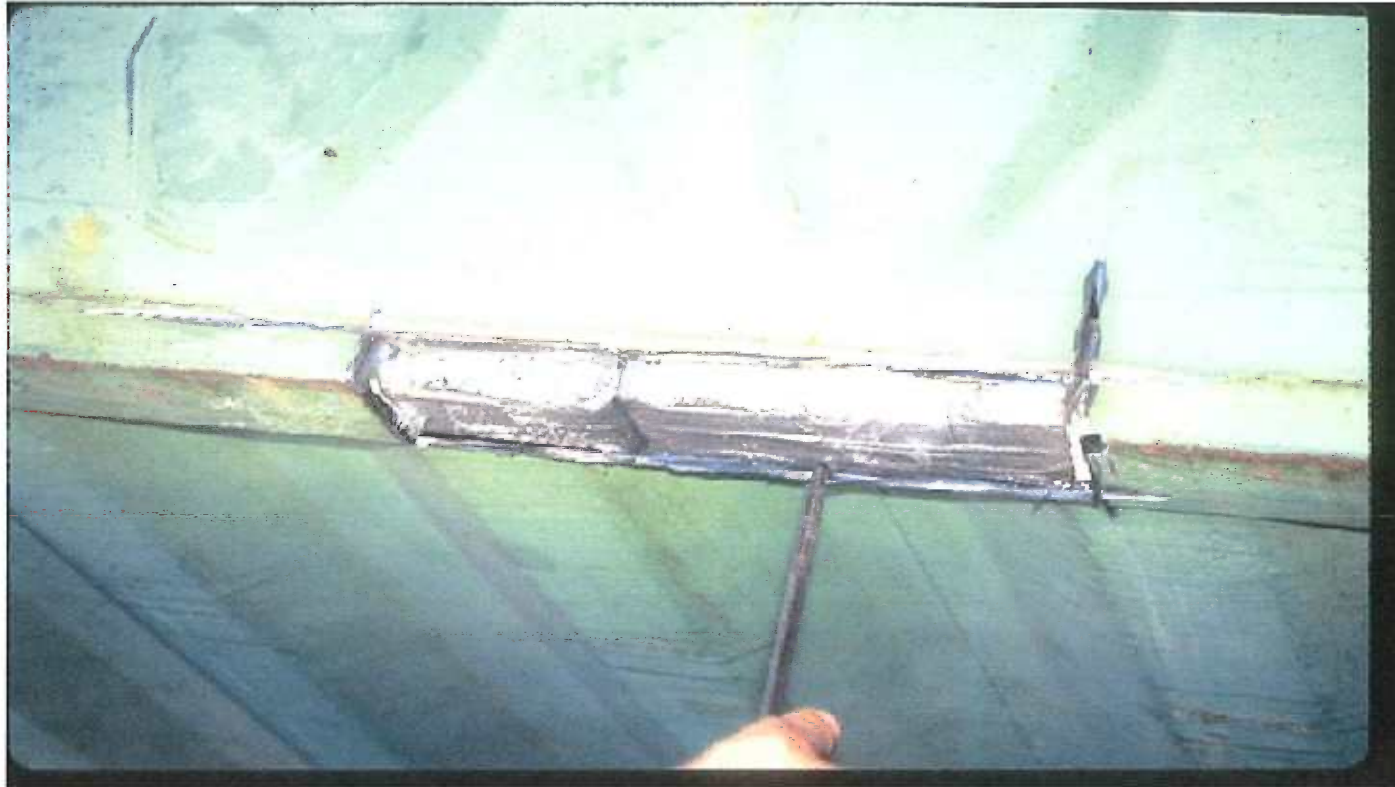
17 Container Shipment/ 1,275 lbs. of cocaine

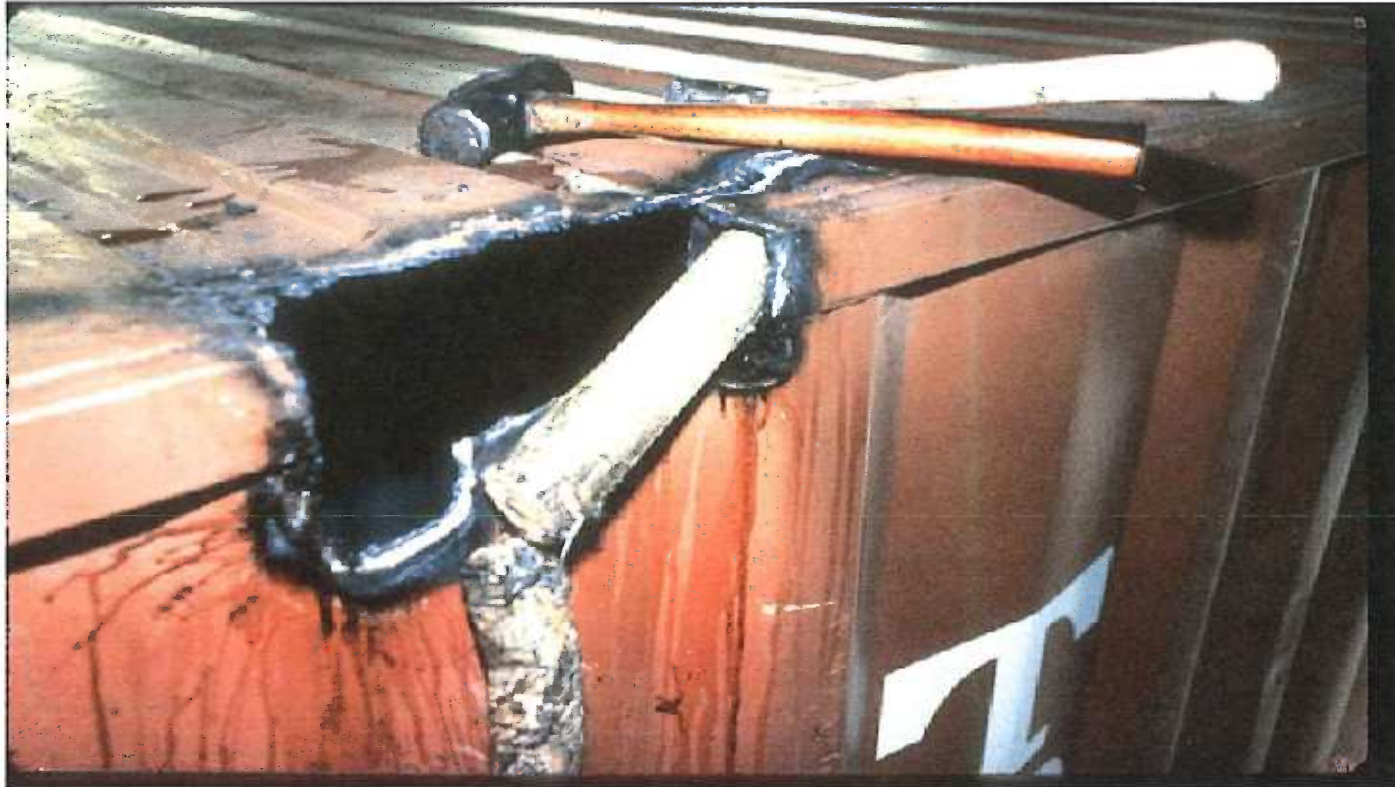
55 lbs. of cocaine/ One beam!

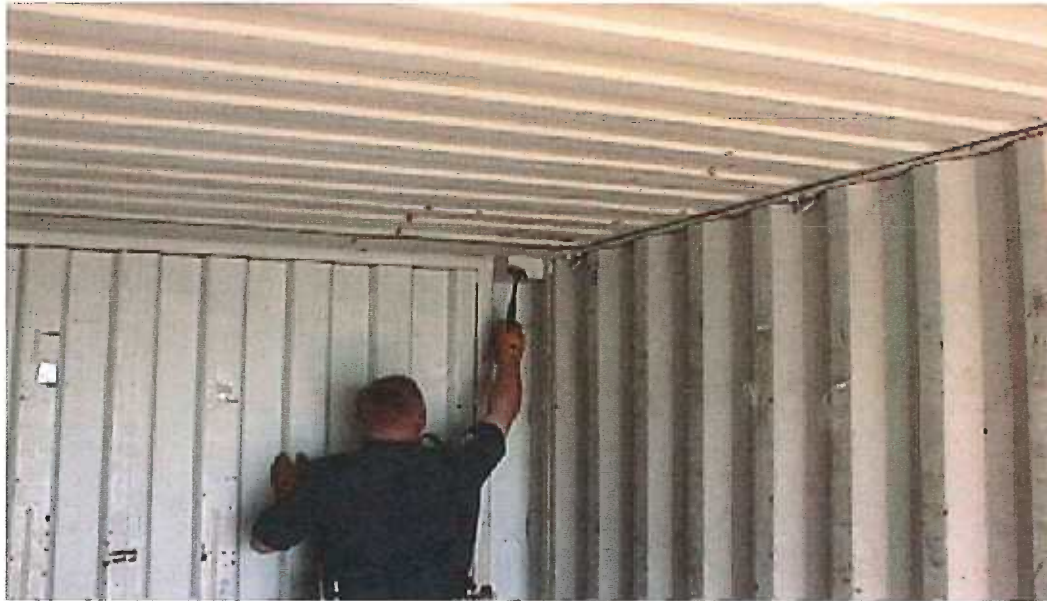
- Blocks and vents are visible.
- Use tool to tap front wall. Listen and feel for hollow sound!
- Range finder, measuring tape and/or string can be utilized to determine the length of container.

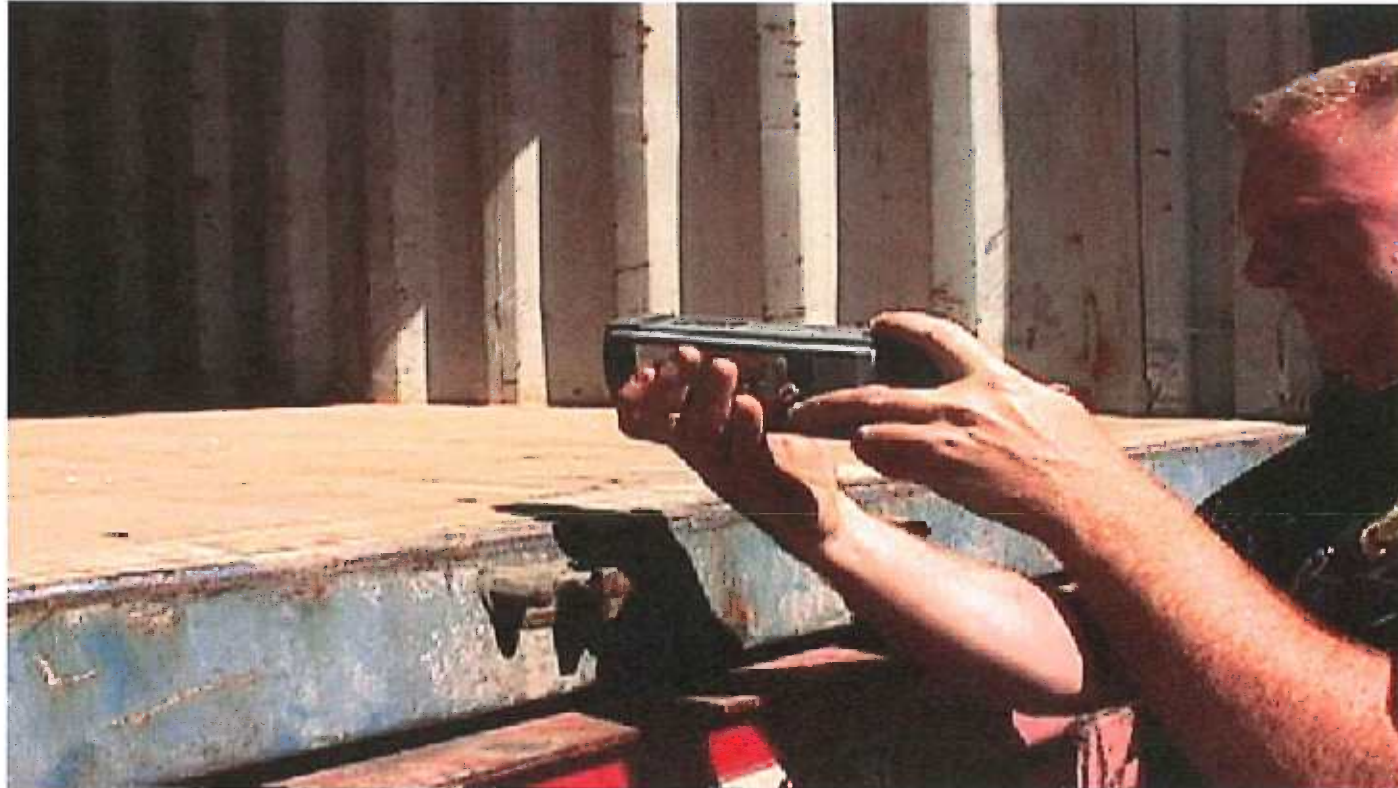
Use laser range finder from door opening.

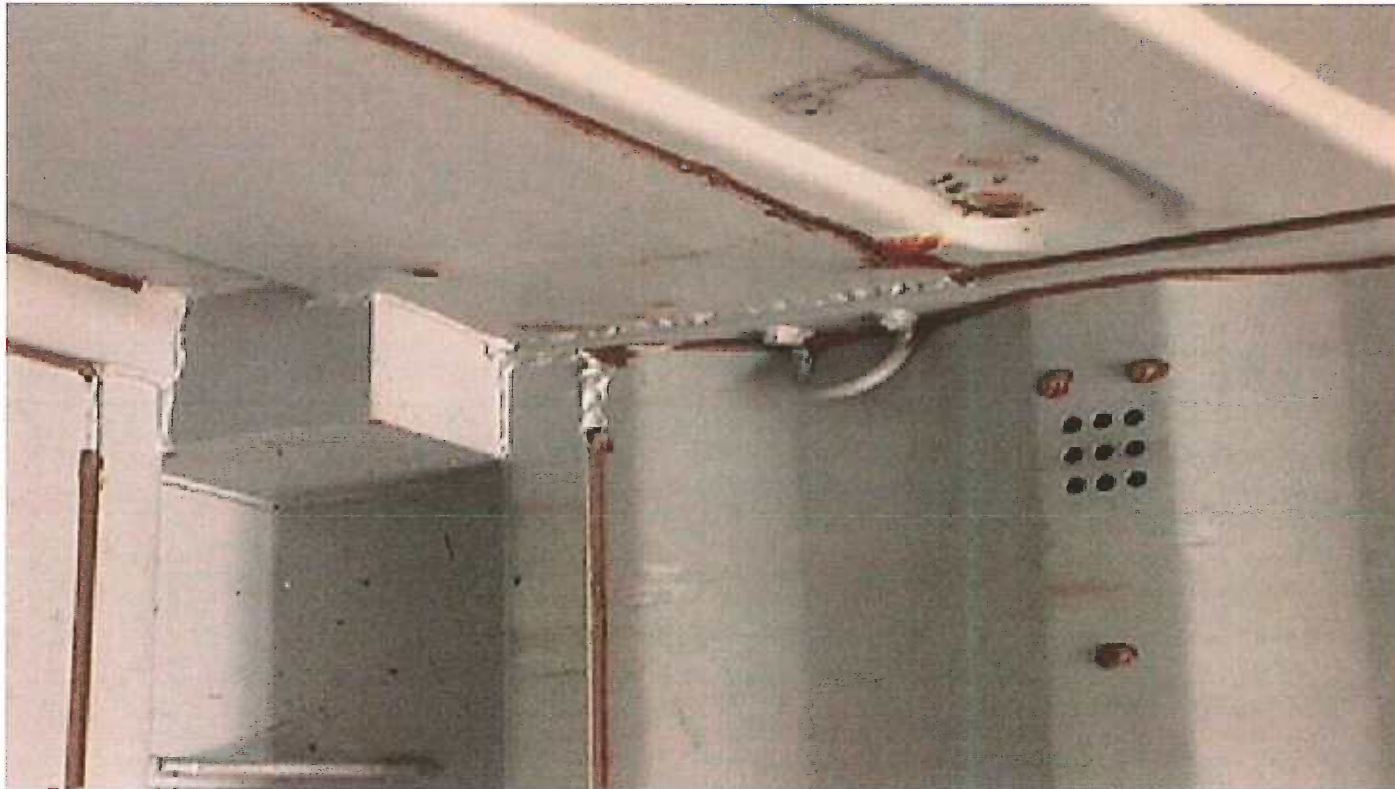
Normal block and air vent

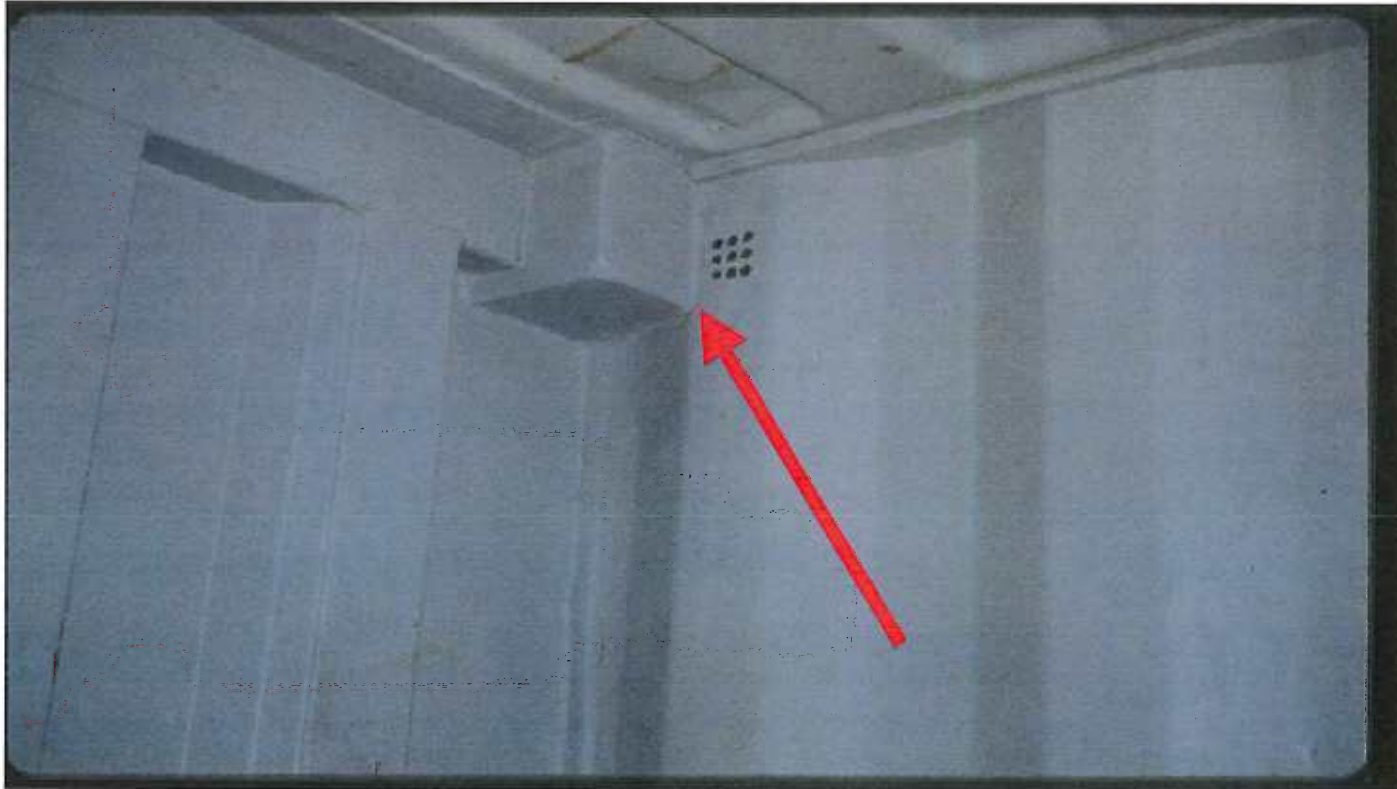
Short distance between block and vent. Wall colors are different!

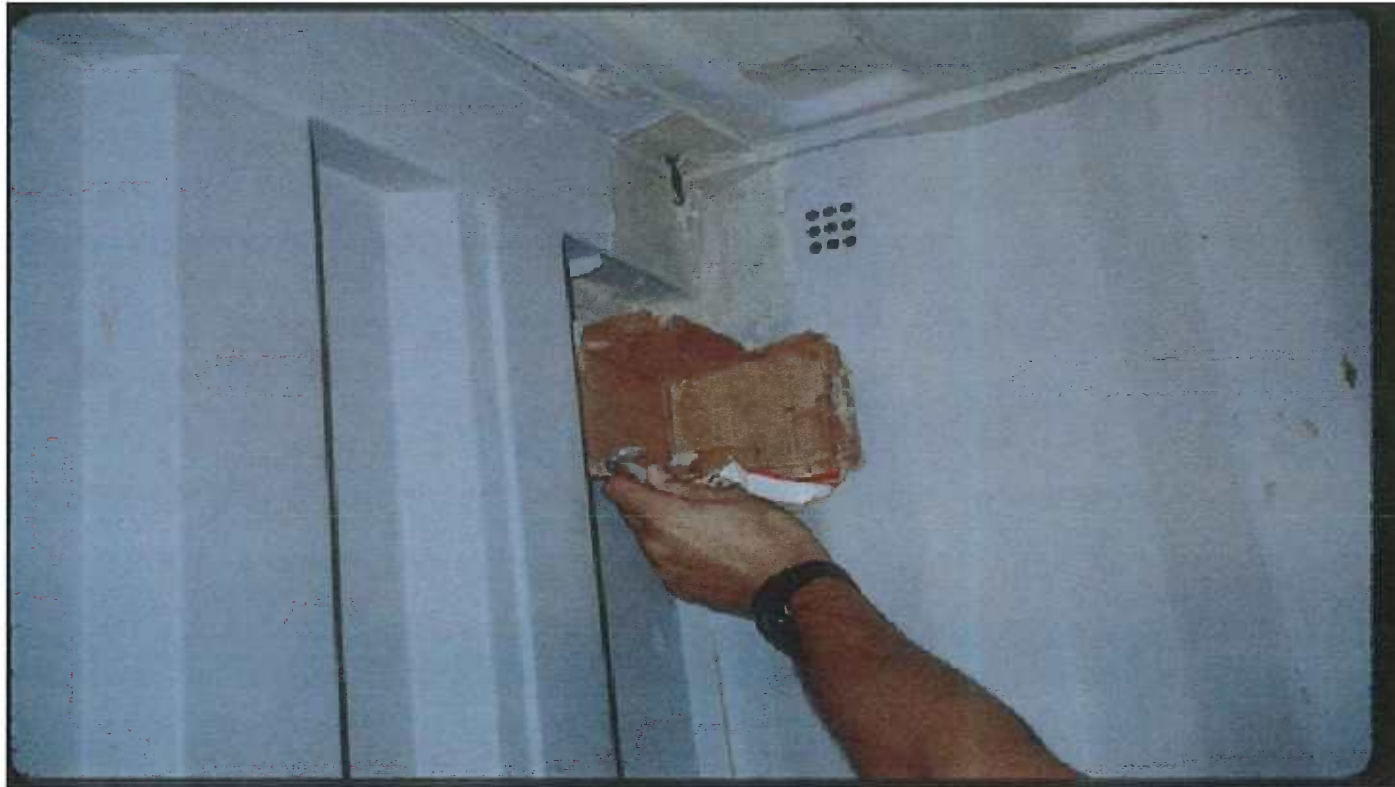
Fake block made out of cardboard!

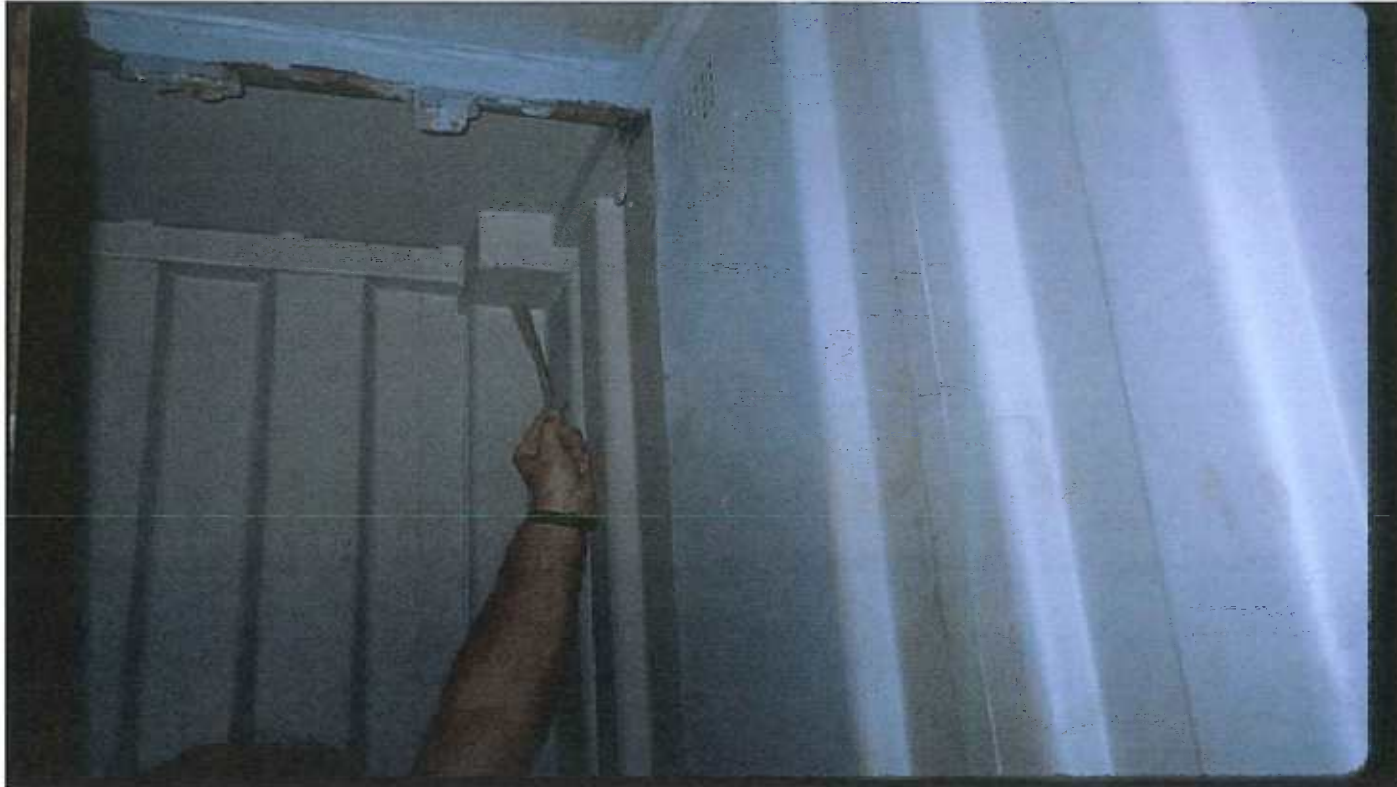
Real block concealed behind false wall.

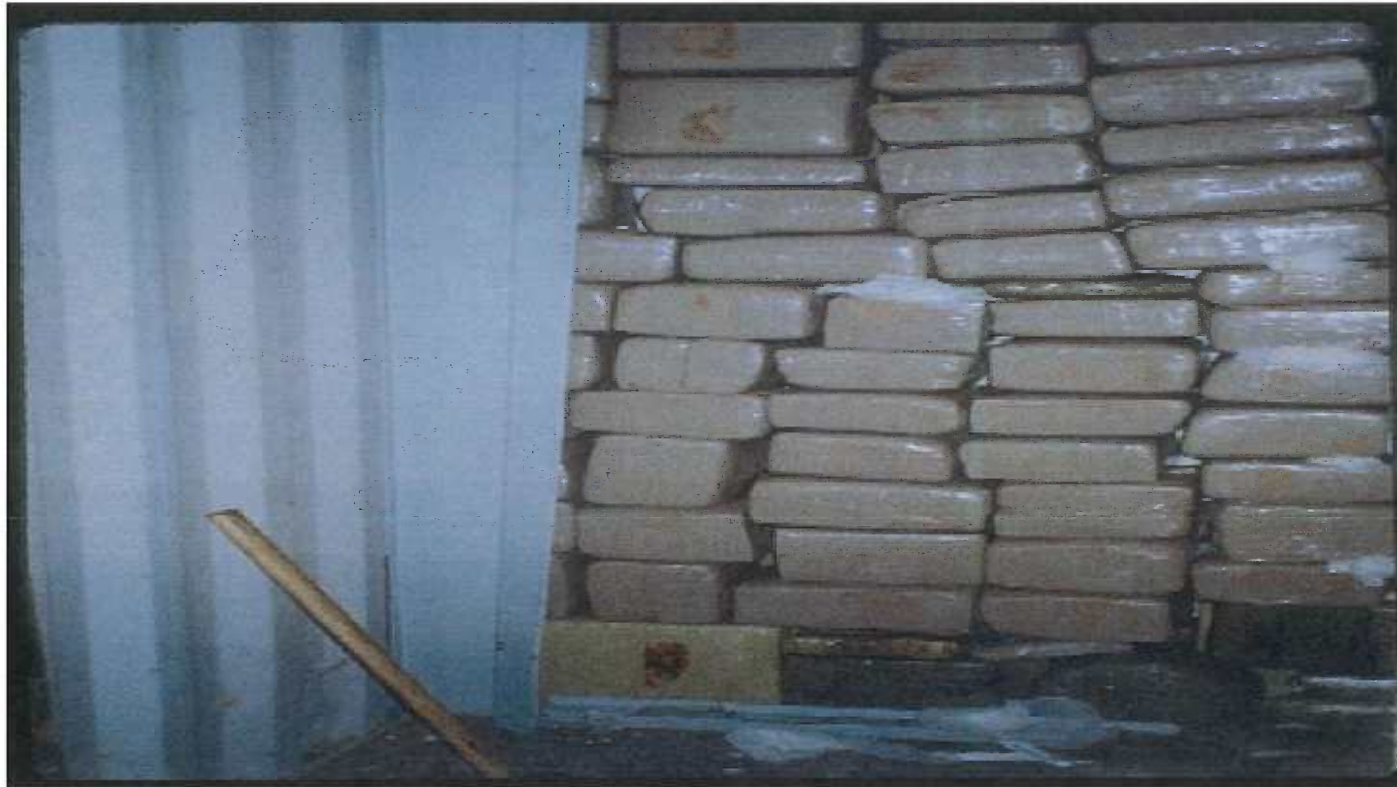
1,290 lbs. Marijuana. Range finder used.

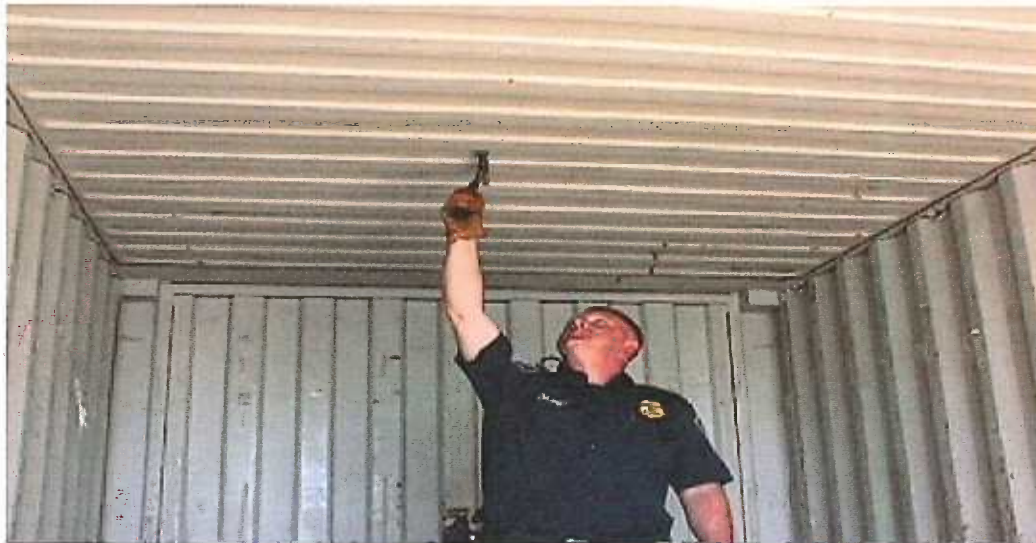
- Ceiling is a certain height from floor. Blocks & vents are visible.
- Uncomfortable feeling inside container.
- Repairs to the ceiling on the inside of the container should be visible on the outside.
- Use tool to tap ceiling. Listen for hollow sound.

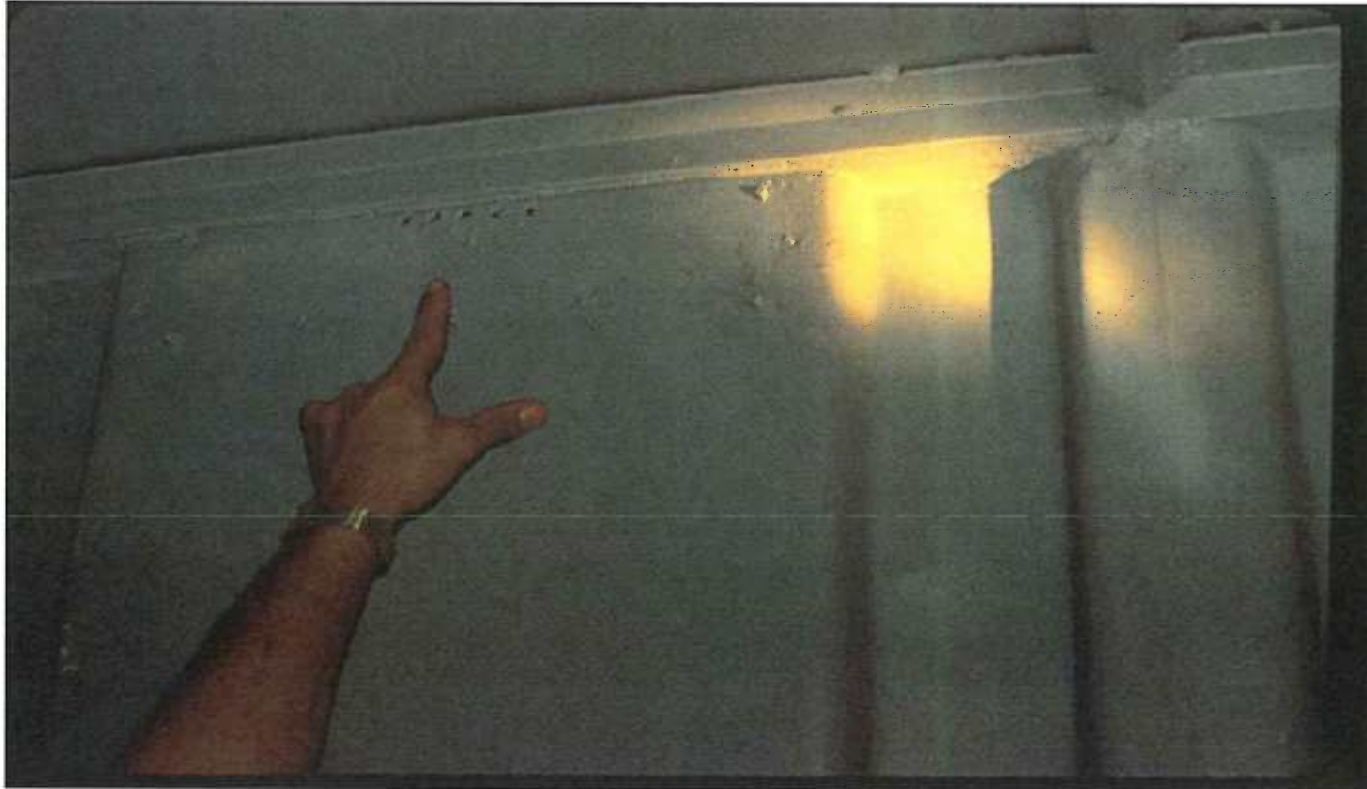
One row of vent holes visible.
