Container Inspection...

7-Point Container Inspection Process:

Supply Chain Security in a New Business Environment

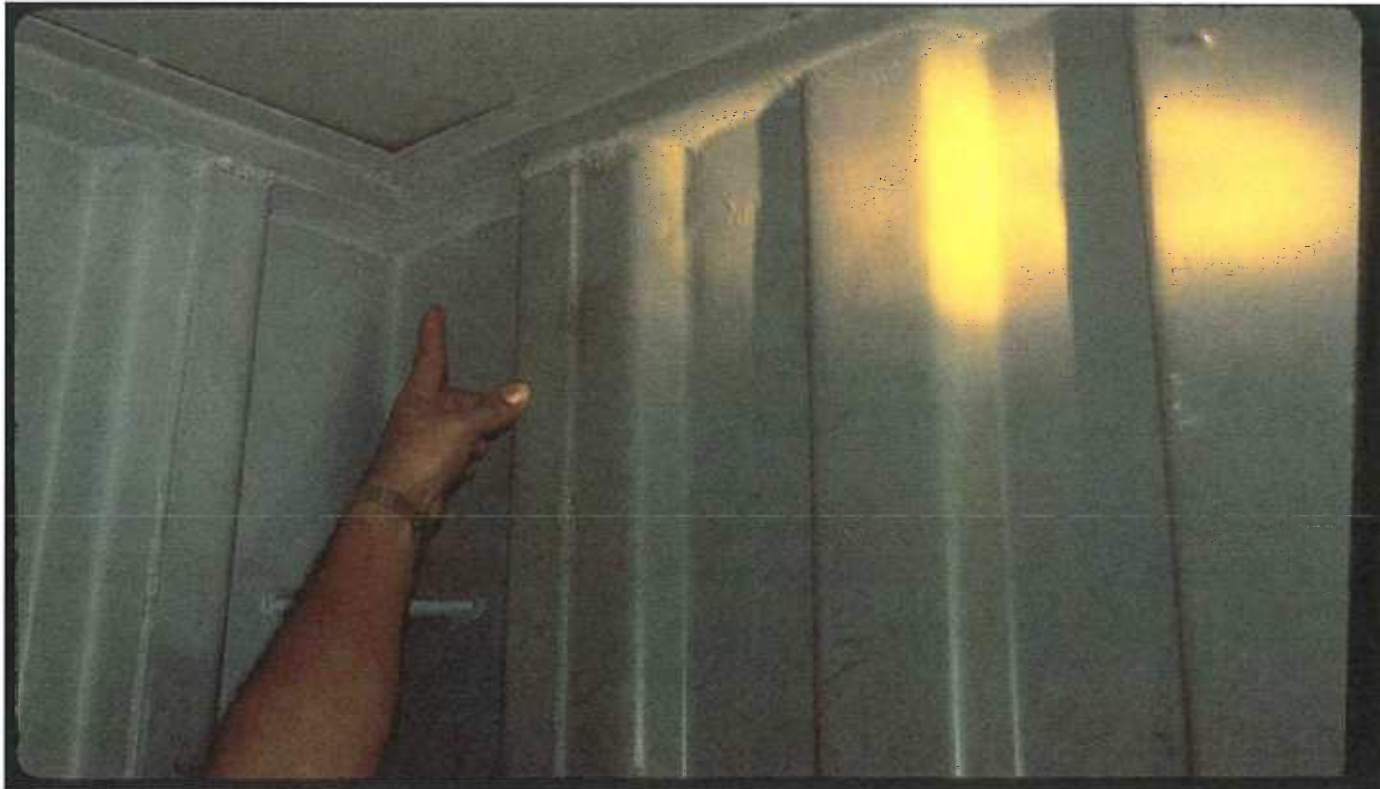
Blocks are not visible.

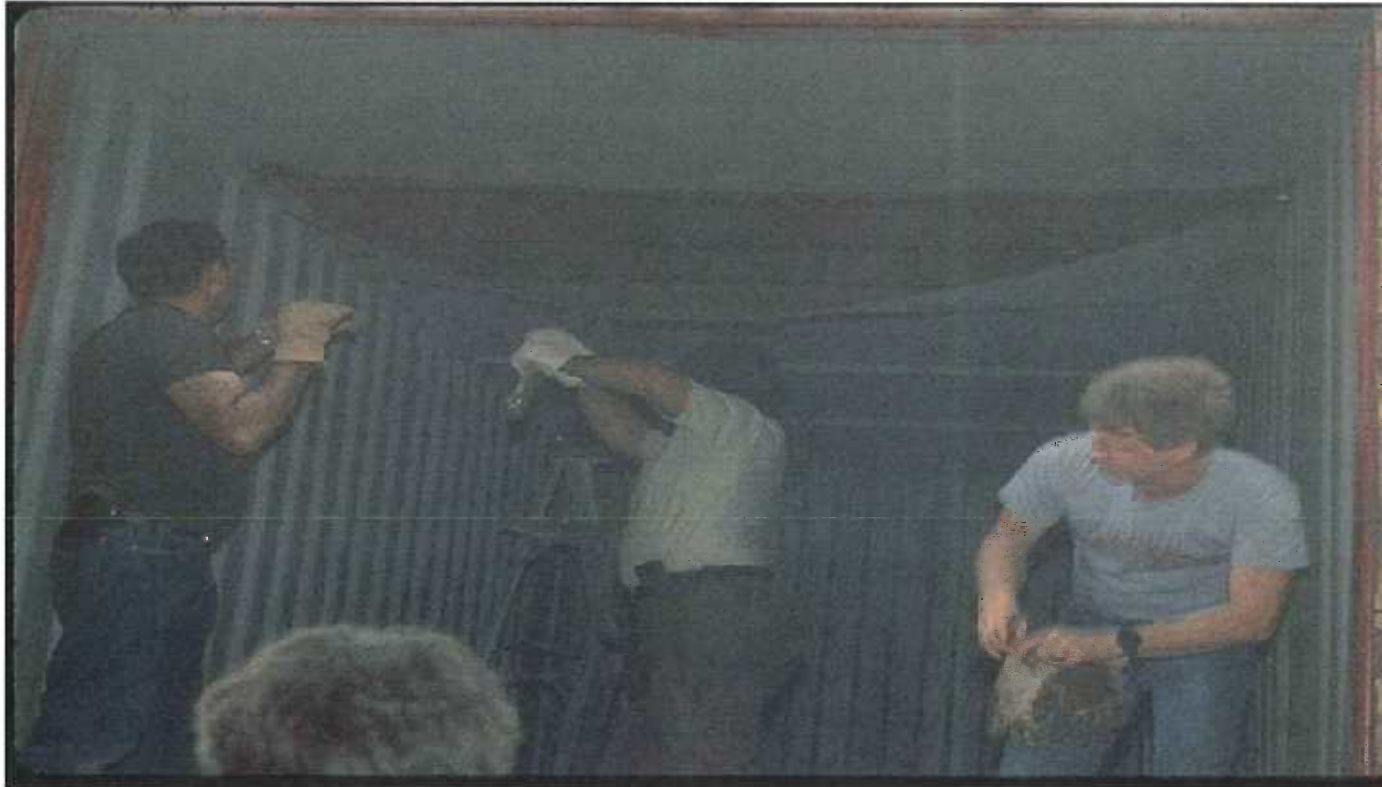
1,200 lbs. of cocaine!

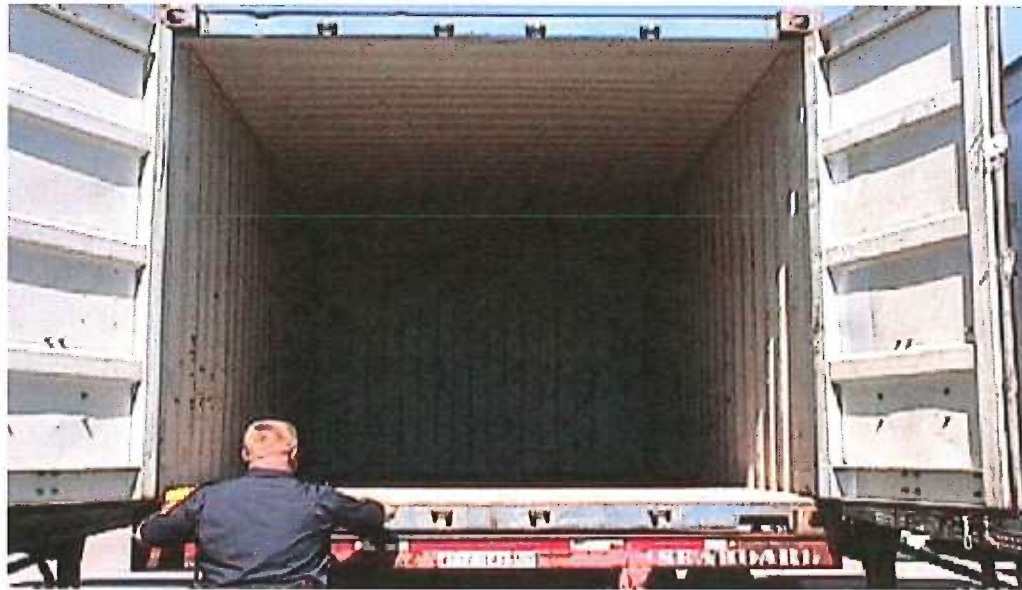
- Floor should be a certain height from the ceiling
- Floor should be flat. Do not need to step up to get inside!
- Different floor heights
- Unusual repairs

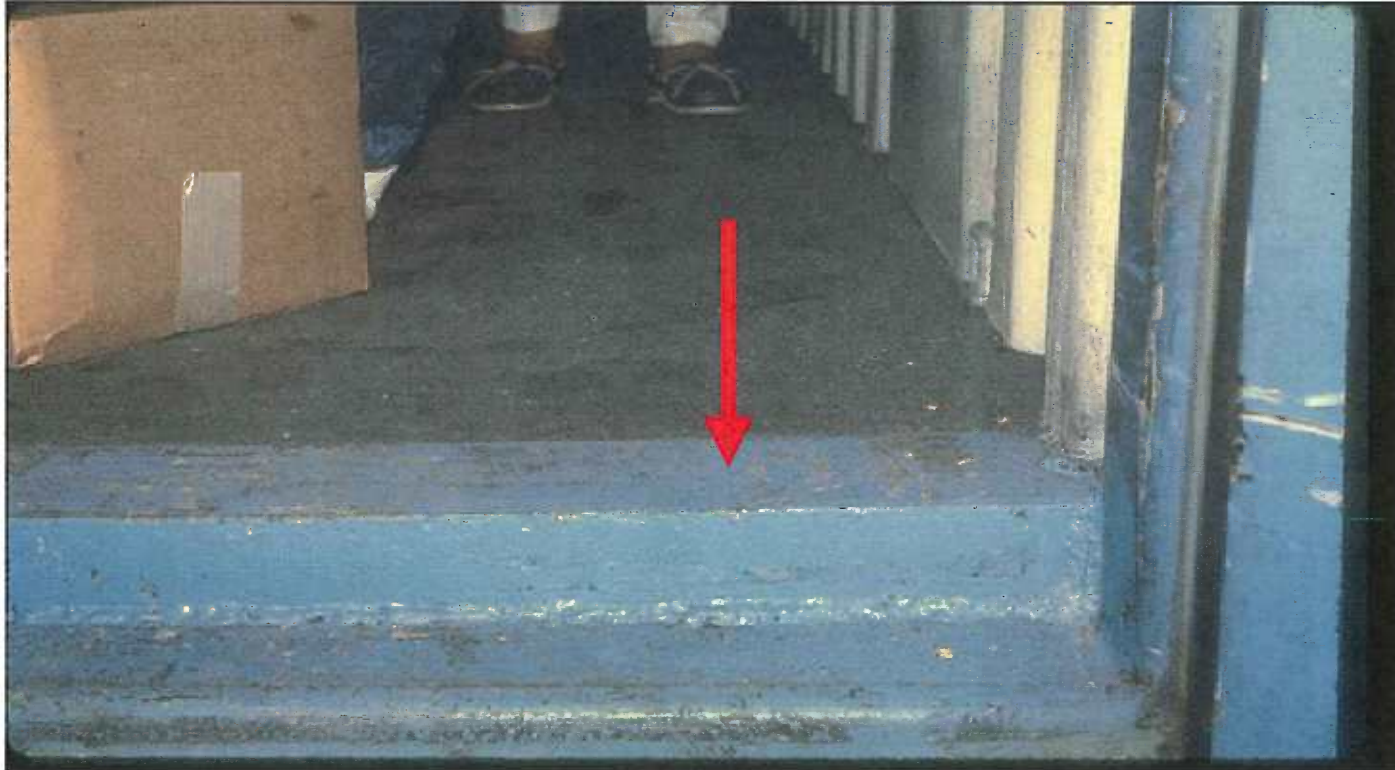
Step up to get inside! Why?

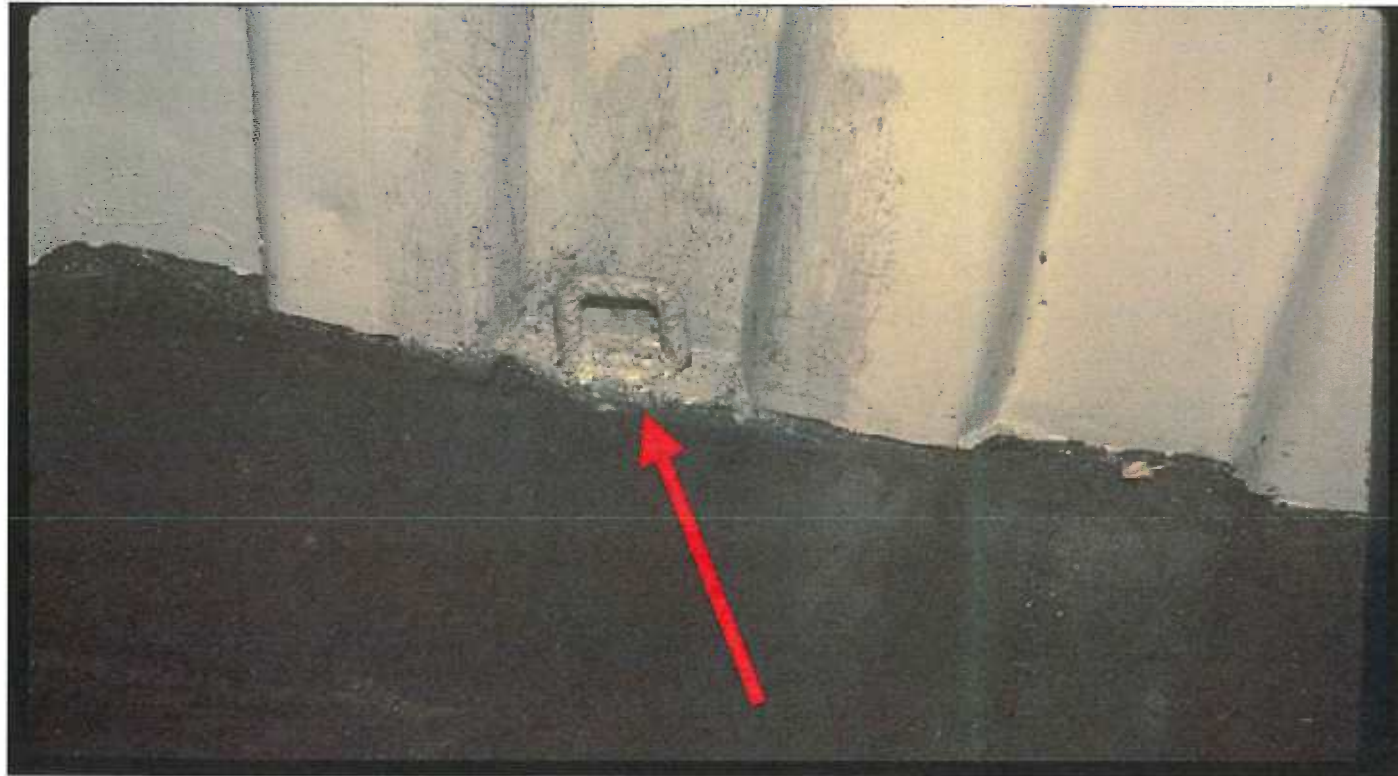
Sloppy repairs and welding.

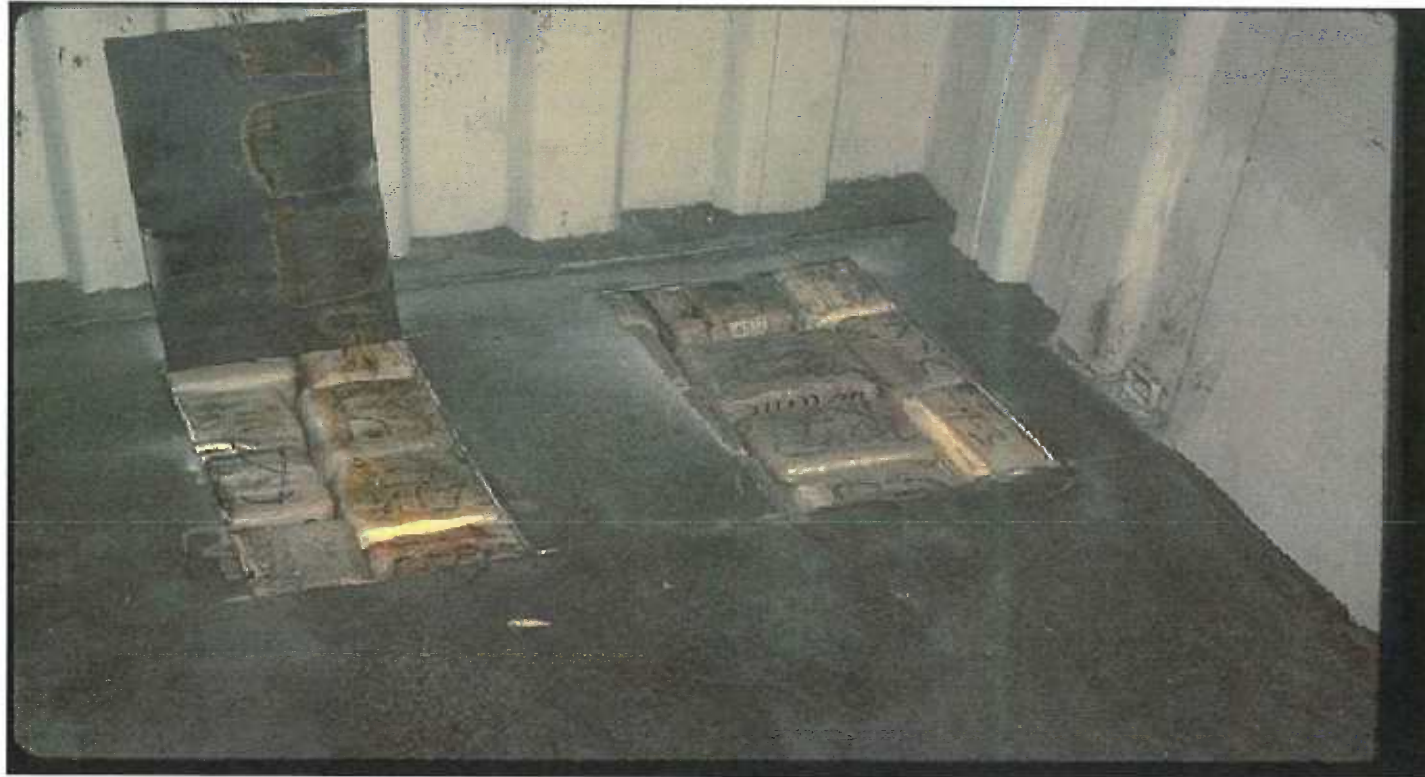
Welded steel plates/1,300 lbs. of cocaine underneath the plates!

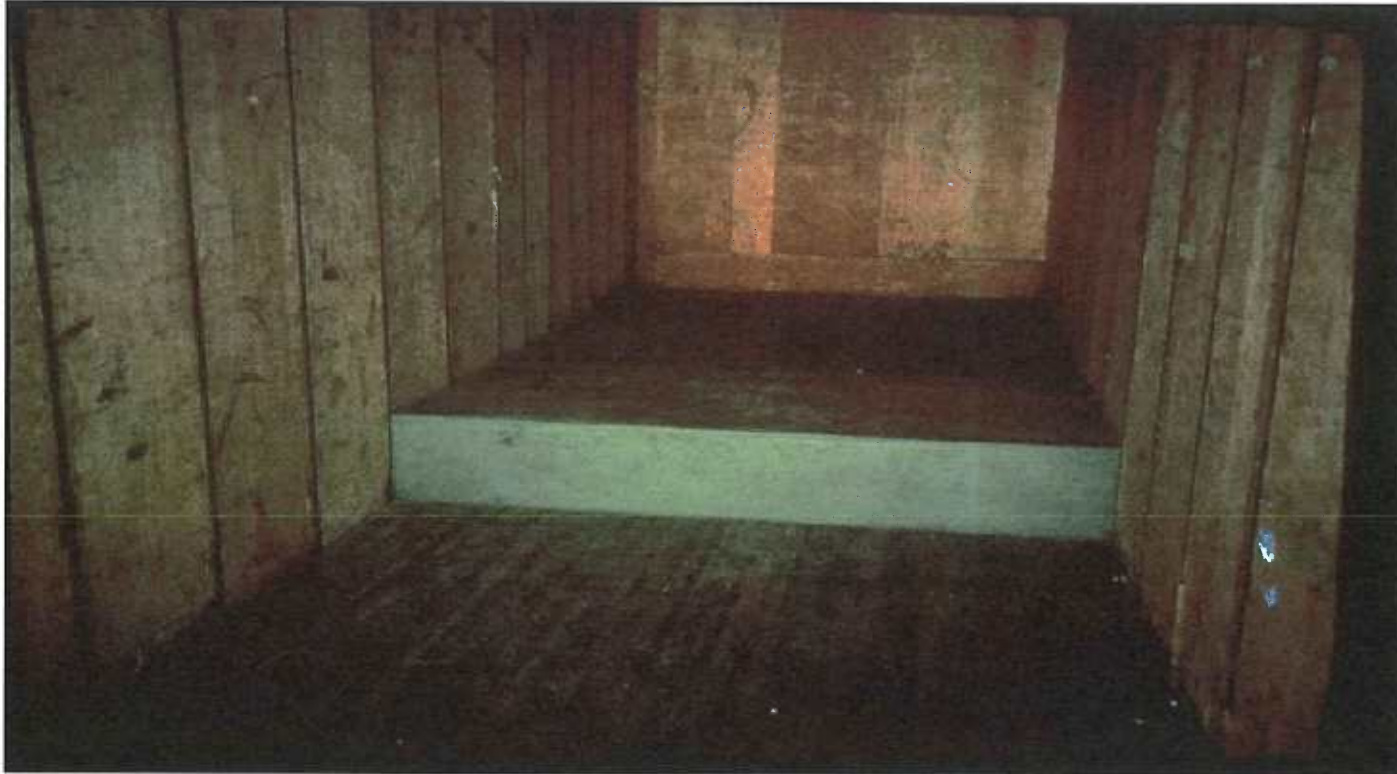
False compartment/ 550 lbs. of cocaine within compartment!
